COMPUTERIZED DESIGN AND FABRICATION OF GOLD CROWN

Mileidy Gonzalez-Negreira University of Pennsylvania School of Dental Medicine, Philadelphia, Pennsylvania, United States

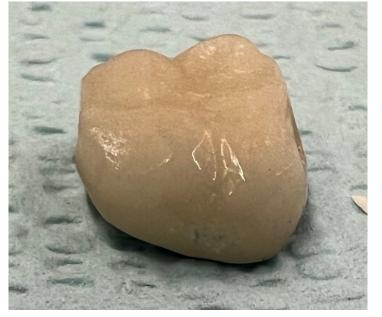
57-year-old female patient presents to Penn Dental Medicine with a chief complaint "my crown fell off." Upon clinical and radiographic examination, existing porcelain fused to metal (PFM) crown on tooth #31 had been debonded most likely due to recurrent caries on the mesial ((Figures 1-4).

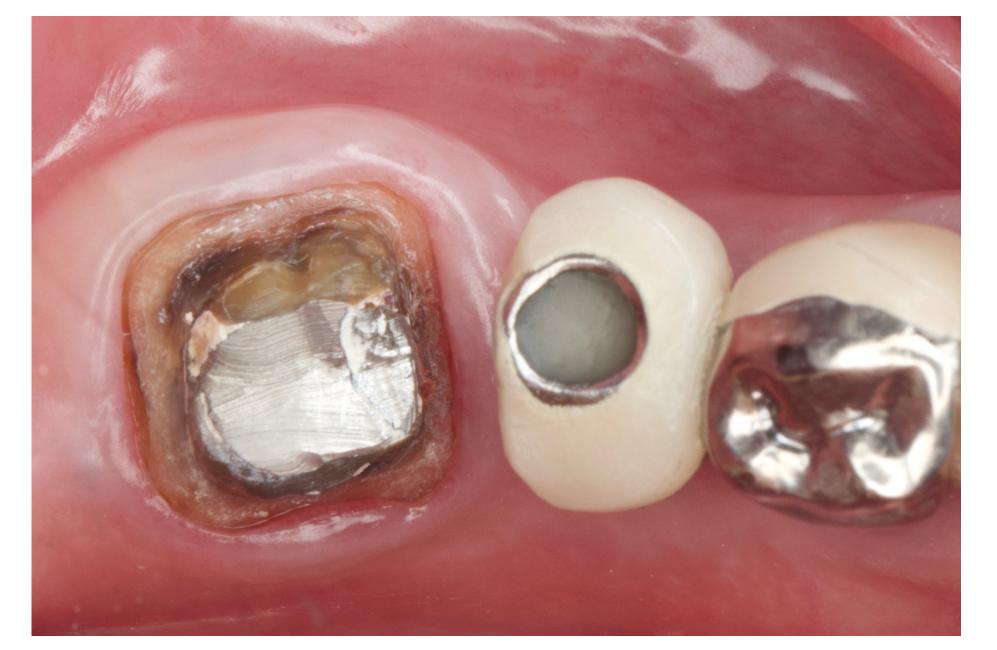
Figure 5. Preparation of tooth #31 and re-contoured implant crown of tooth #30

After the removal of the failed PFM crown and existing mesial decay, the tooth was re-prepared maintaining the existing amalgam core, reducing the margins gingivally, and choosing a chamfer marginal design (Figure 5).
